LAKE FREDERICK DAM  
ORANGE COUNTY, NEW YORK  
INVENTORY NO. 769

PHASE I INSPECTION REPORT  
NATIONAL DAM SAFETY PROGRAM

DECEMBER 1978

HUDSON RIVER BASIN  
LAKE FREDERICK DAM  
INVENTORY NO. 769  
PHASE I INSPECTION REPORT

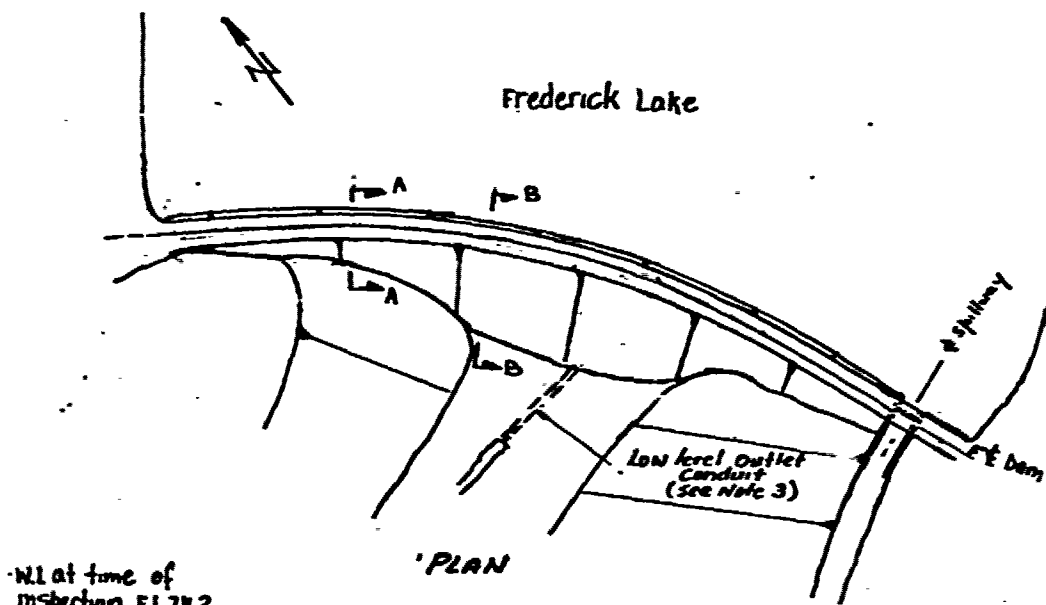
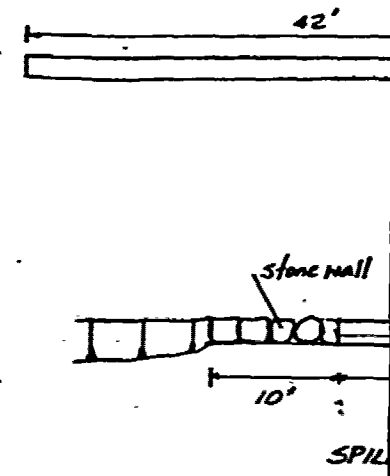
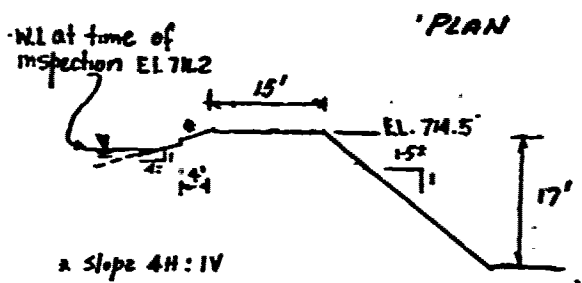
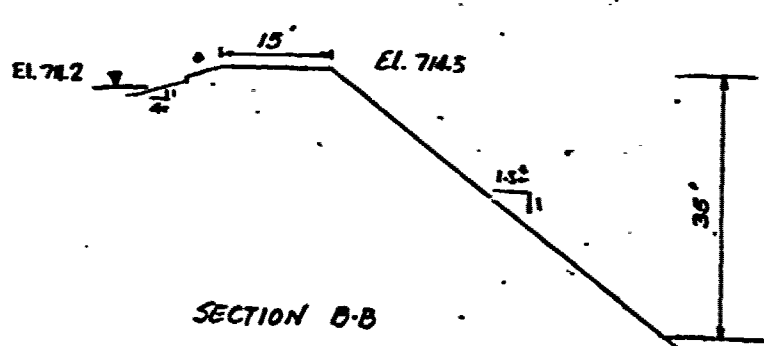
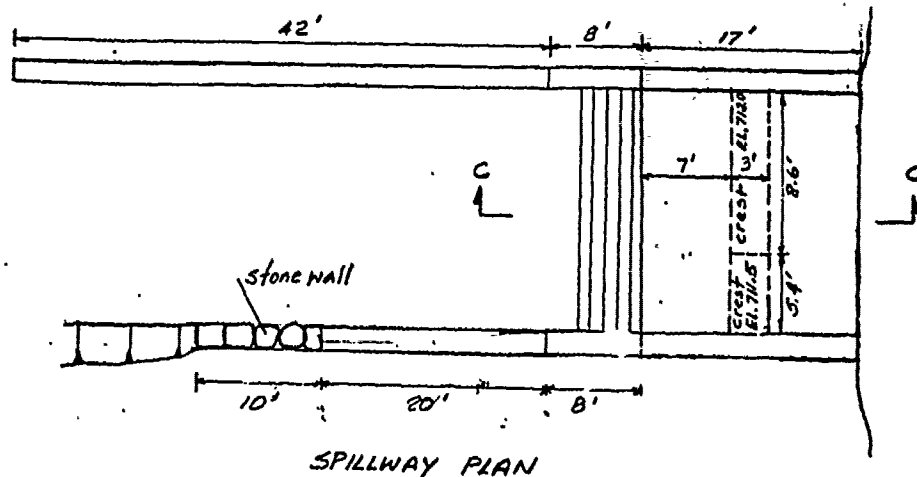
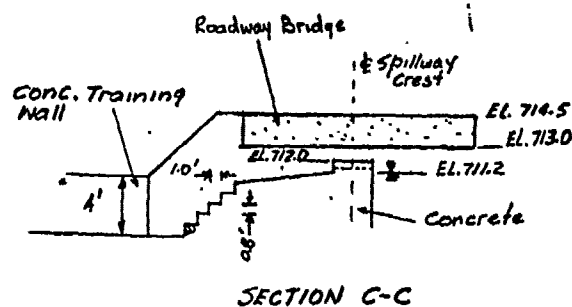
PHASE I DAM IN

1. Drawing based on rough field measurements made during visual inspection.
- 2 All elevations referred to M.S.L.
- 3 upstream extent and Controls are unknown.
